# Prominent fibula

# With Your® Liner

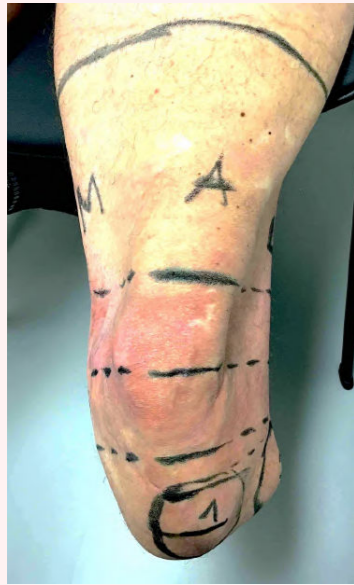
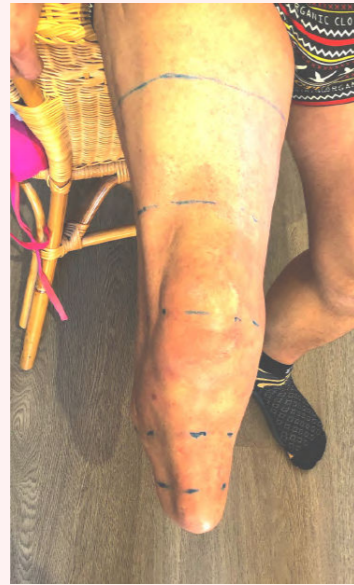
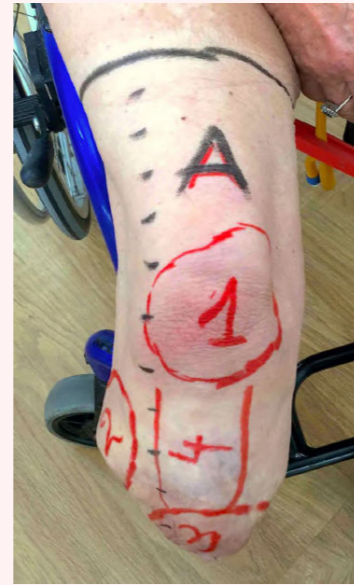
The fibula protrudes laterally. This area causes pain if exposed to pressure. Skin in this area can be prone to recurrent injuries.

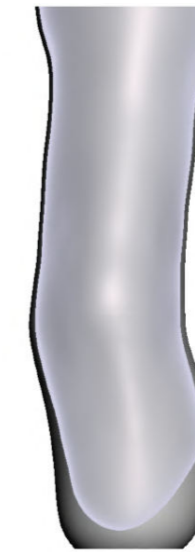
3D model

As it's made from a 3D scan, Your® Liner's inner shape can match the protruding fibula shape, thus eliminating the risk of the liner being over-stretched and applying extra-compression on the fibula.

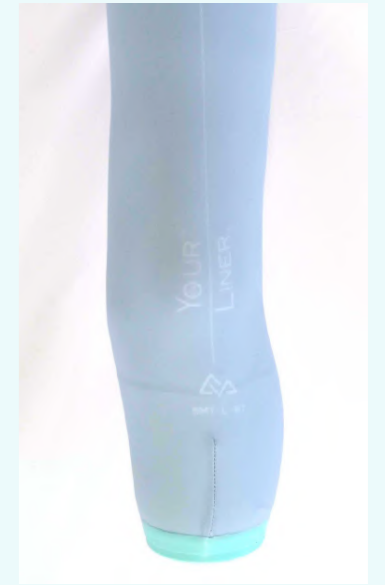
Your® Liner

The possibility of locally applying adequate cushioning allows to apply adequate elastomer thickness to limit the risk of pressure peaks appearing on the fibula. The rest of the liner can present a thin profile to avoid the risks heavy liner, additional pistoning and lowered proprioception.
